# TECHNICAL REPORT

### ***Assess collision risk with powerlines and mapping high risk areas at key sites in Bulgaria***

***Conservation of the Dalmatian Pelican along the Black-Sea Mediterranean Flyway/Pelican Way of Life***

***LIFE18 NAT/NL/000716***

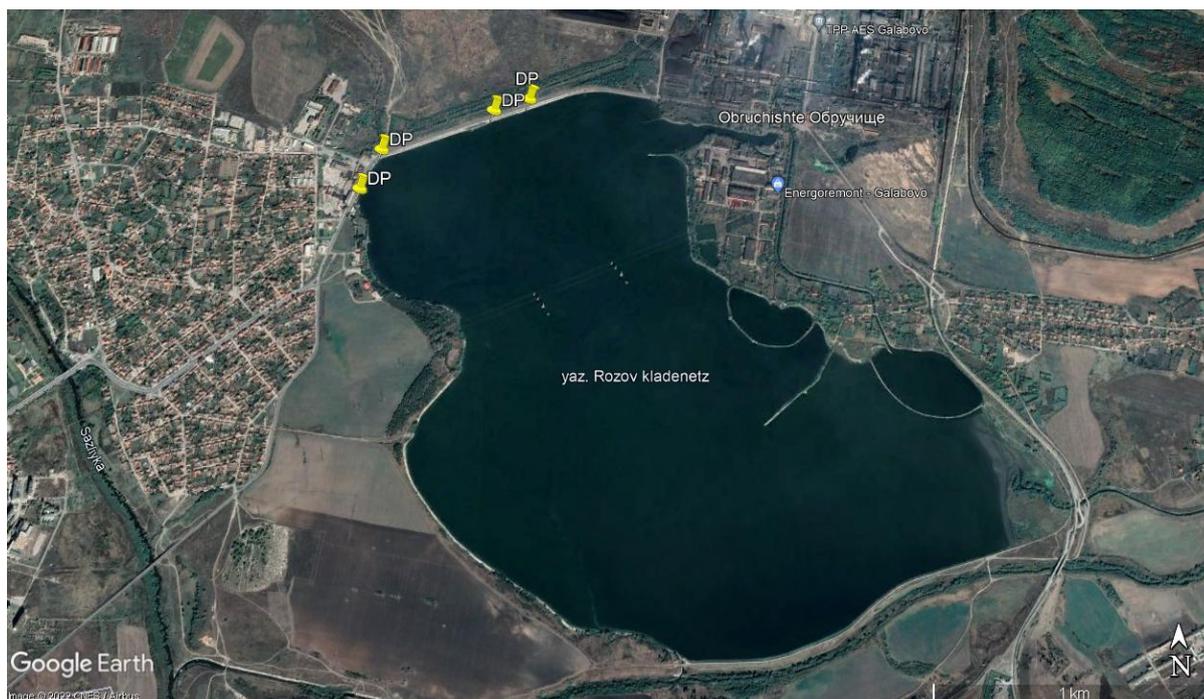
Map with found dead Dalmatian pelicans at Rozov Kladenets dam

2 ind. Dalmatian pelicans were found dead in December 2021 and another 2 ind. were found dead in January 2022 in the region of the Rozov Kladenetz dam because of collisions with power lines. An adult injured bird was found at Rozov kladenets dam and was rescued by a BSPB team.

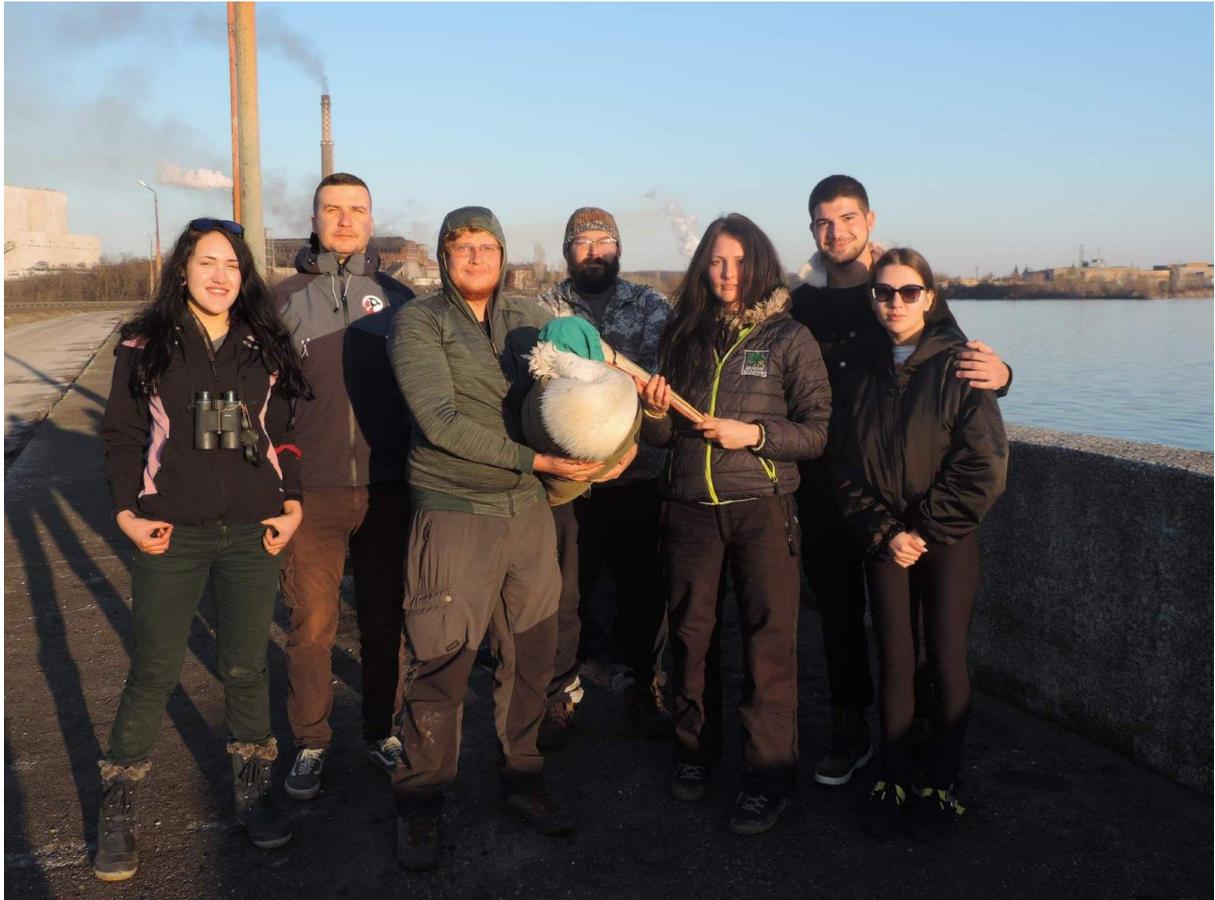
**The BSPB team found an adult Dalmatian Pelican injured in a result of collision with power lines close to the wall of the Rozov Kladenets dam**

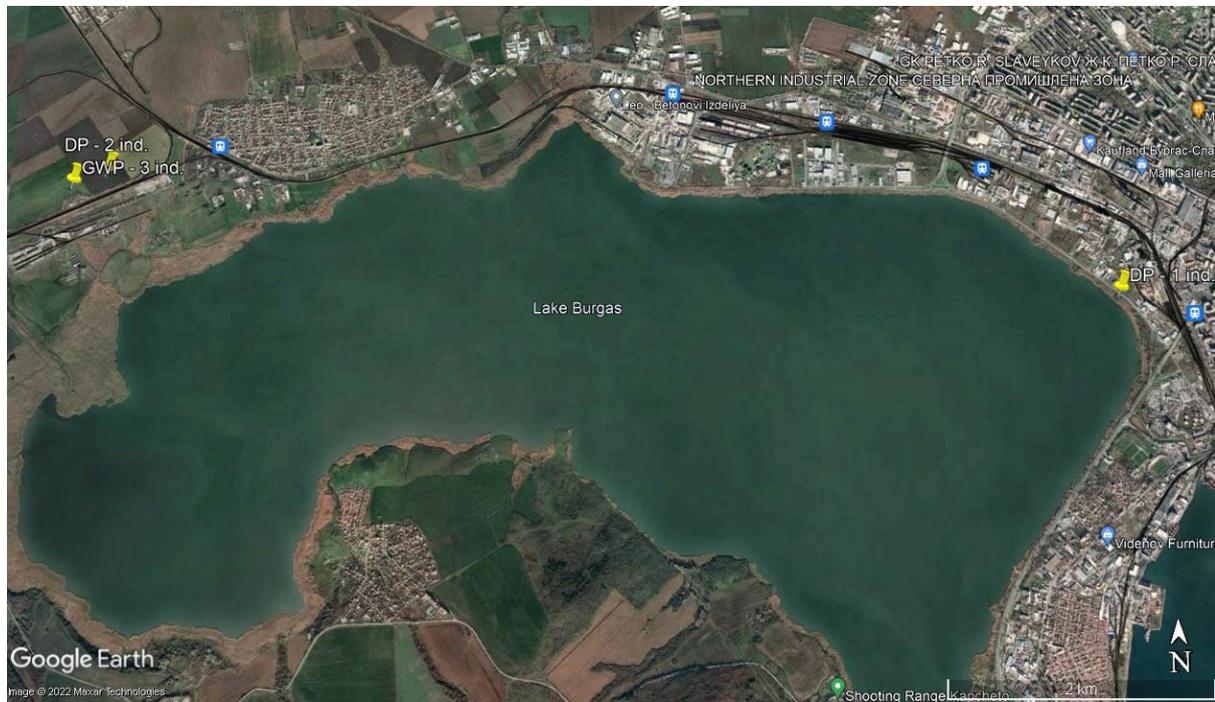
Map with found dead pelicans at Burgasko Lake

3 ind. Dalmatian pelicans were found in April 2020 and January 2022 and 3 Great White pelicans were found dead in April 2020 in the region of the Burgasko Lake because of collisions with power lines.

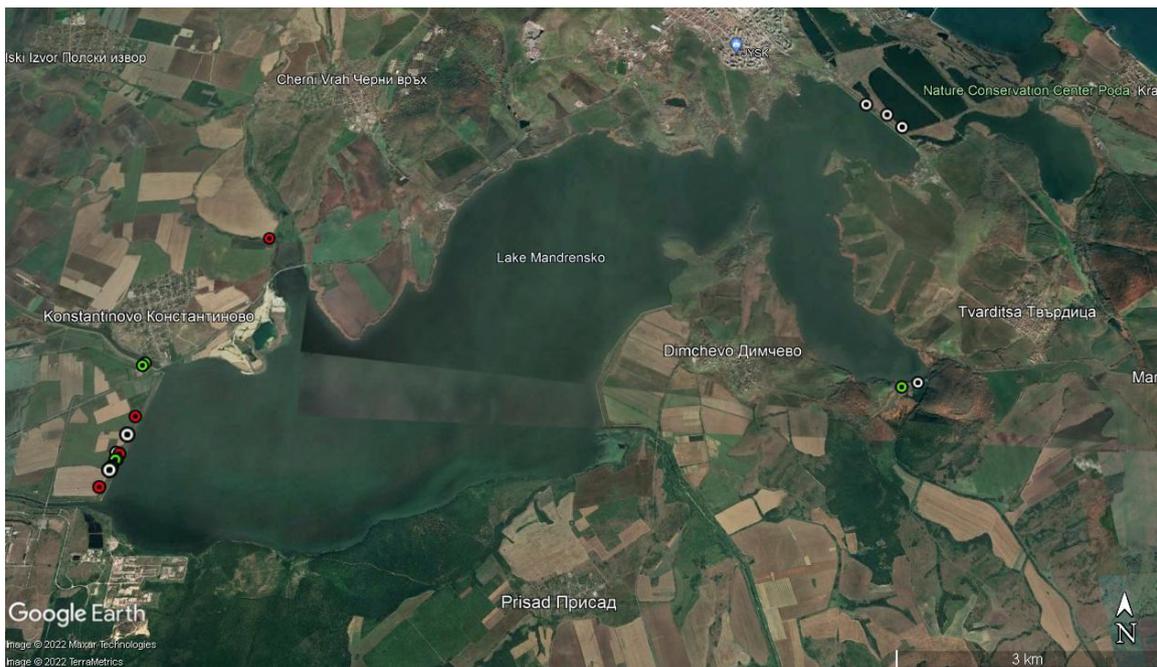
Map with found dead pelicans at Mandra-Poda Complex

In 2020 17 pelicans (15 Great White pelicans and 2 Dalmatian pelicans) were found dead in April and 1 ind. Great White Pelican found in May at Mandra-Poda Complex because of collisions with power lines. In 2021 another 4 ind. Great White pelicans and 4 ind. Dalmatian pelicans were found dead in April 2021 at the same areas because of collisions. In January 2022 2 ind. Dalmatian pelicans were found dead close to the Mandra reservoir's wall again because of collision.

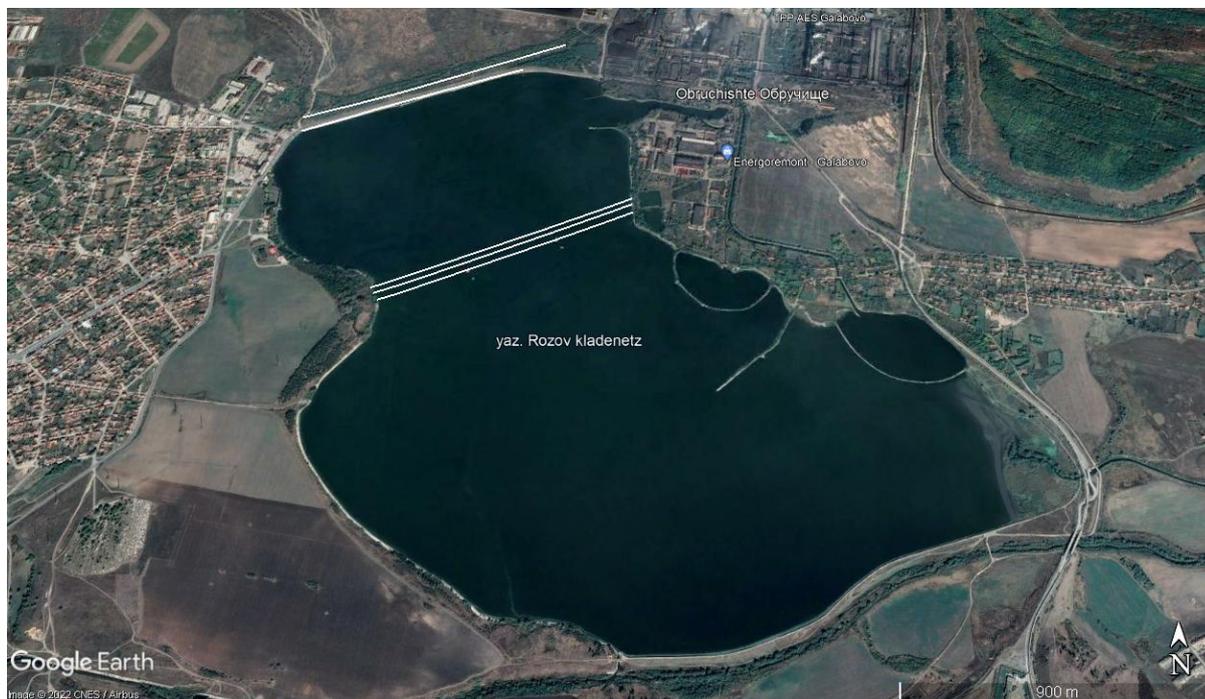
### 7.1. SPA Yazovir Rozov Kladenets BG0002022 – 4.96 km hazardous power lines

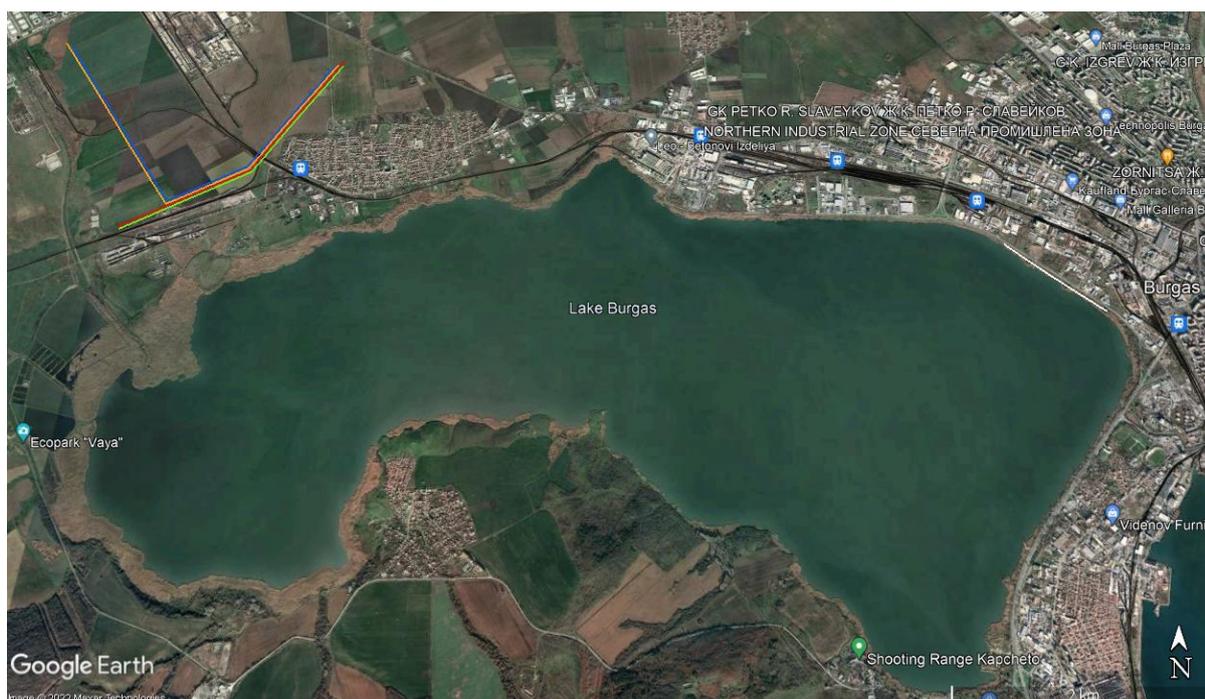
### 7.2. SPA Burgasko Lake BG0000273 – 13.09 km hazardous power lines, located at NE and NW part of the project site.

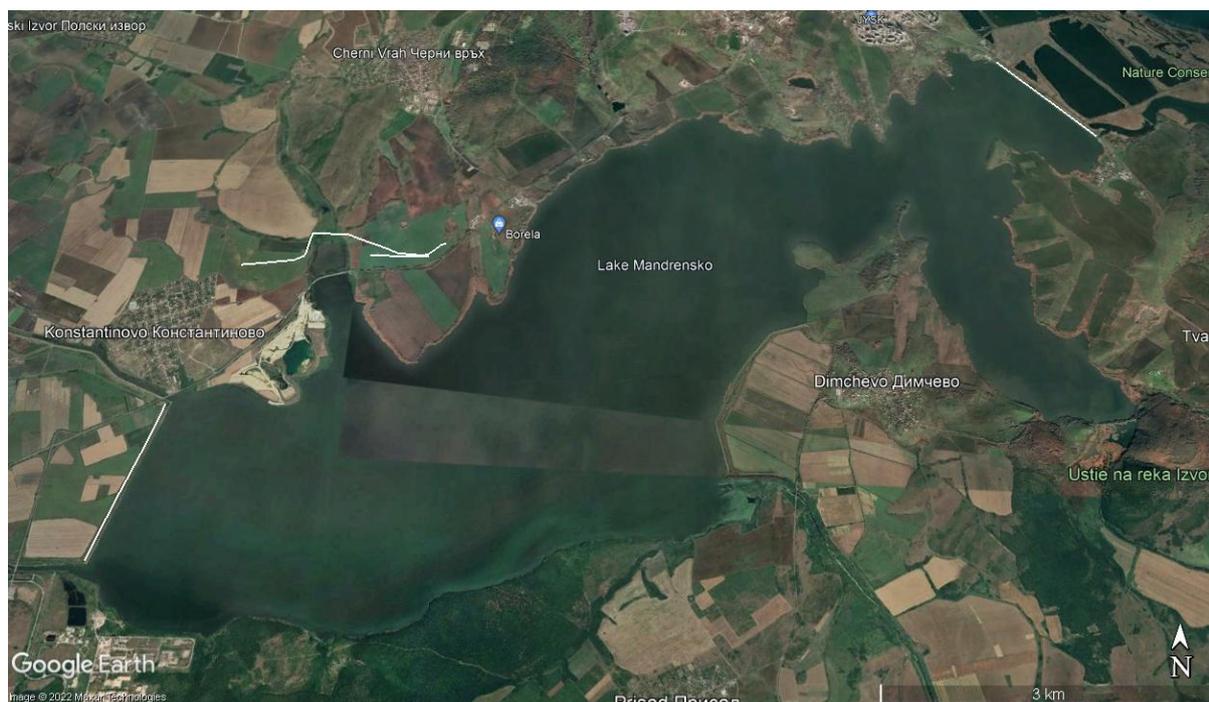
**7.3. SPA Mandra-Poda Complex BG0000271 – 6.56 km hazardous power lines, located at W, NW and NE part of the project site.**

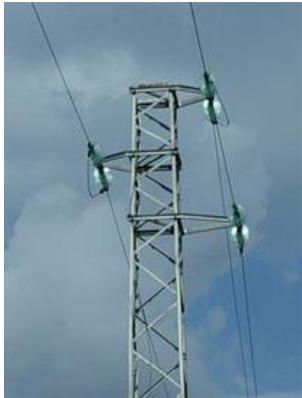
1

- **Type 1** – tension lattice towers with 3 isolators attached sideways;
- **Type 2** – reinforced concrete pylons with 3 standing isolators;
- **Type 3** – lattice towers with 6 isolators positioned on 2 support beams in a downward direction (dual line with hanging isolators);

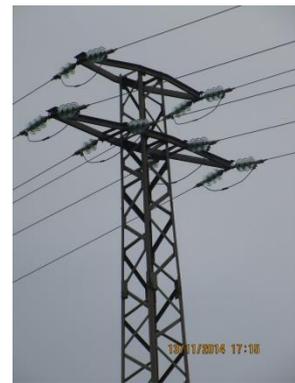
9

- **Type 9** – dual tensioning lattice towers with 6 isolators positioned on 2 support beams in a sideways position with jumper conductors.
